Asbestos Management Survey Report

35 - 42 Amber Court, Swindon, SN1 2HB

Date of Survey:	23 Dec 2015
Date of Report:	14 Jan 2016
Job No:	<u>J006560</u>
Authorising Surveyor:	Dean O Sullivan
Verified/Signature:

Management Survey of the communal areas

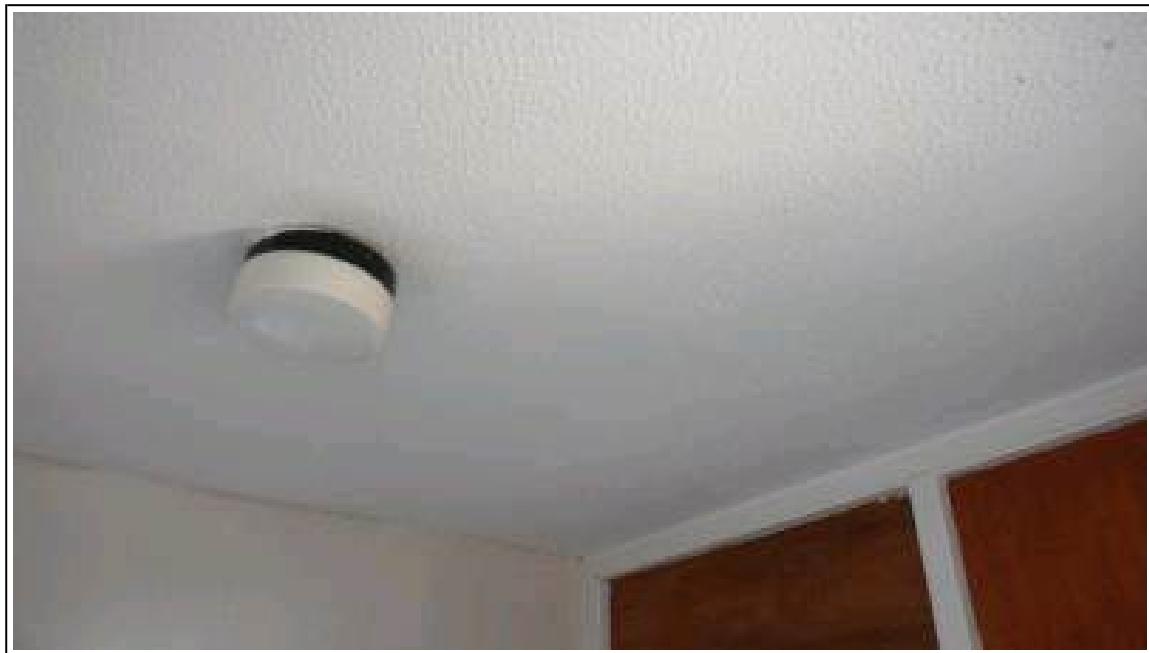
Survey Data Sheet: Conclusions & Recommendations
 Site Location: 35 - 42 Amber Court, Swindon, SN1 2HB
 Building Designation: Building 01
 Unique item Number: 1

Sample Ref	Fl	Location	Description	Qty	Analysis Result	Total M.A.S	Licensed Material Y/N
AM000001	Ground Floor	Entrance Hall	Ceiling - Textured coating - Textured Coating	7m ²	NADIS		N

No asbestos detected in sample

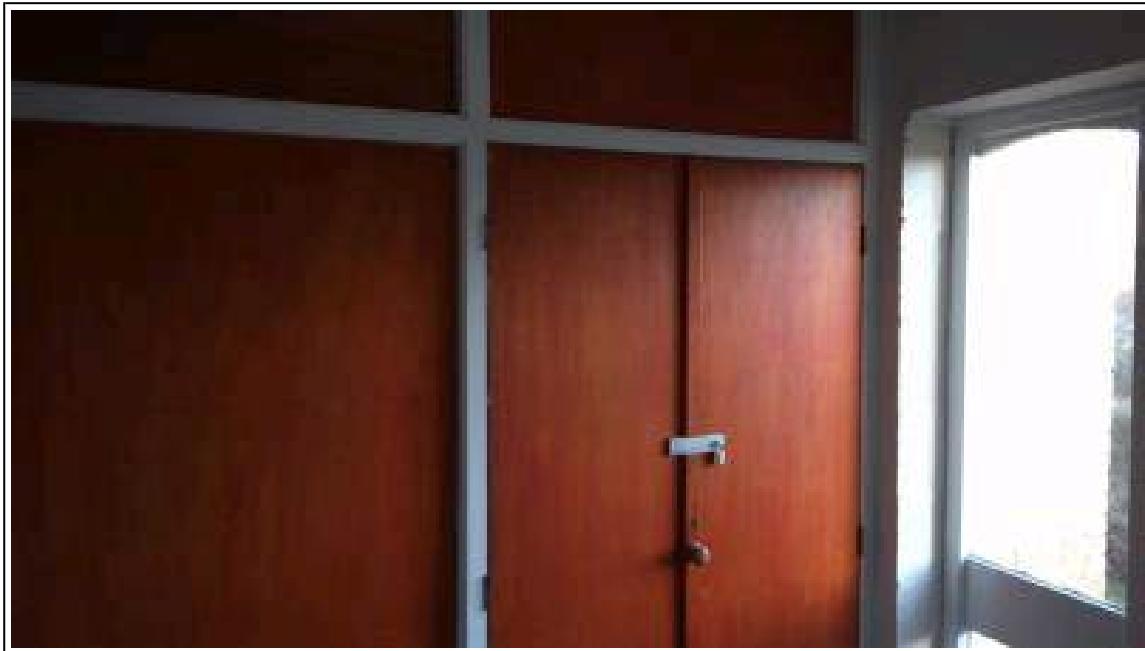
Survey Data Sheet: Conclusions & Recommendations
 Site Location: 35 - 42 Amber Court, Swindon, SN1 2HB
 Building Designation: Building 01
 Unique item Number: 2

Sample Ref	Fl	Location	Description	Qty	Analysis Result	Total M.A.S	Licensed Material Y/N
Surveyed	Ground Floor	Electrical Cupboard	No asbestos detected -		N/A		N

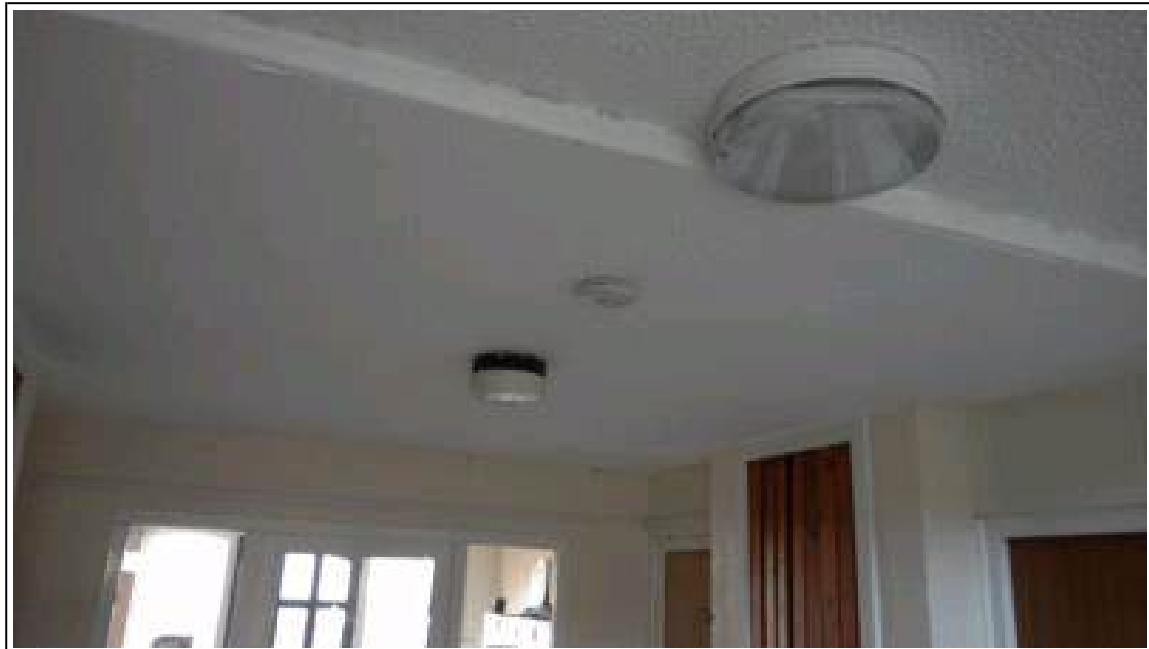
Survey Data Sheet: Conclusions & Recommendations
 Site Location: 35 - 42 Amber Court, Swindon, SN1 2HB
 Building Designation: Building 01
 Unique item Number: 3

Sample Ref	Fl	Location	Description	Qty	Analysis Result	Total M.A.S	Licensed Material Y/N
REFER (AM000001)	Ground Floor	Hallway	Ceiling - Textured coating - Textured Coating	22m ²	NADIS		N

No asbestos detected in sample

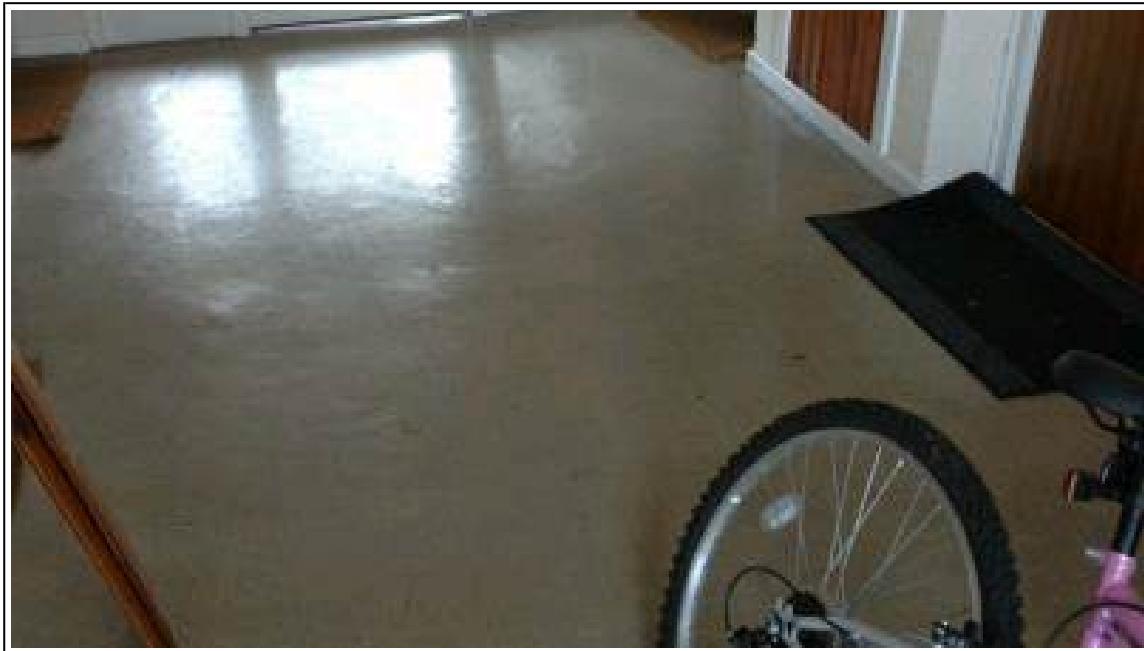
Survey Data Sheet: Conclusions & Recommendations
 Site Location: 35 - 42 Amber Court, Swindon, SN1 2HB
 Building Designation: Building 01
 Unique item Number: 4

Sample Ref	Fl	Location	Description	Qty	Analysis Result	Total M.A.S	Licensed Material Y/N
AM000002	Ground Floor	Hallway	Floor - Floor tiles and adhesive - Well Bound Material	21m ²	NADIS		N

No asbestos detected in sample

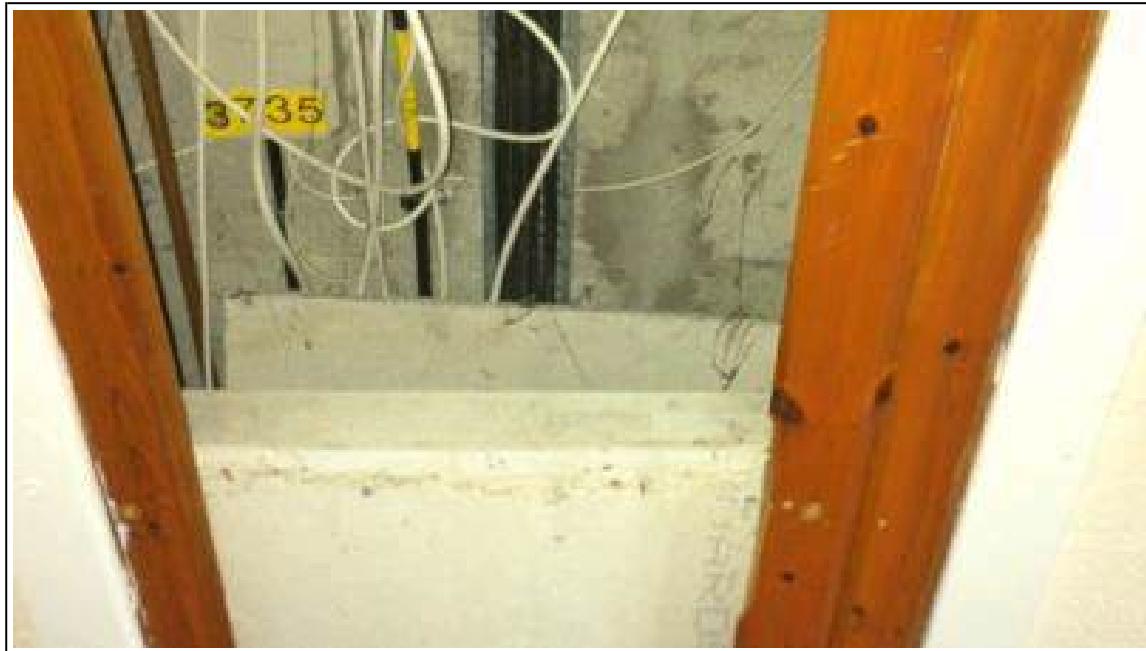
Survey Data Sheet: Conclusions & Recommendations
 Site Location: 35 - 42 Amber Court, Swindon, SN1 2HB
 Building Designation: Building 01
 Unique item Number: 5

Sample Ref	Fl	Location	Description	Qty	Analysis Result	Total M.A.S	Licensed Material Y/N
AM000003	Ground Floor	Riser cupboard 1	Behind access panel and within void - Insulation board panel - Insulating Board	2m ²	NADIS		N

No asbestos detected in sample

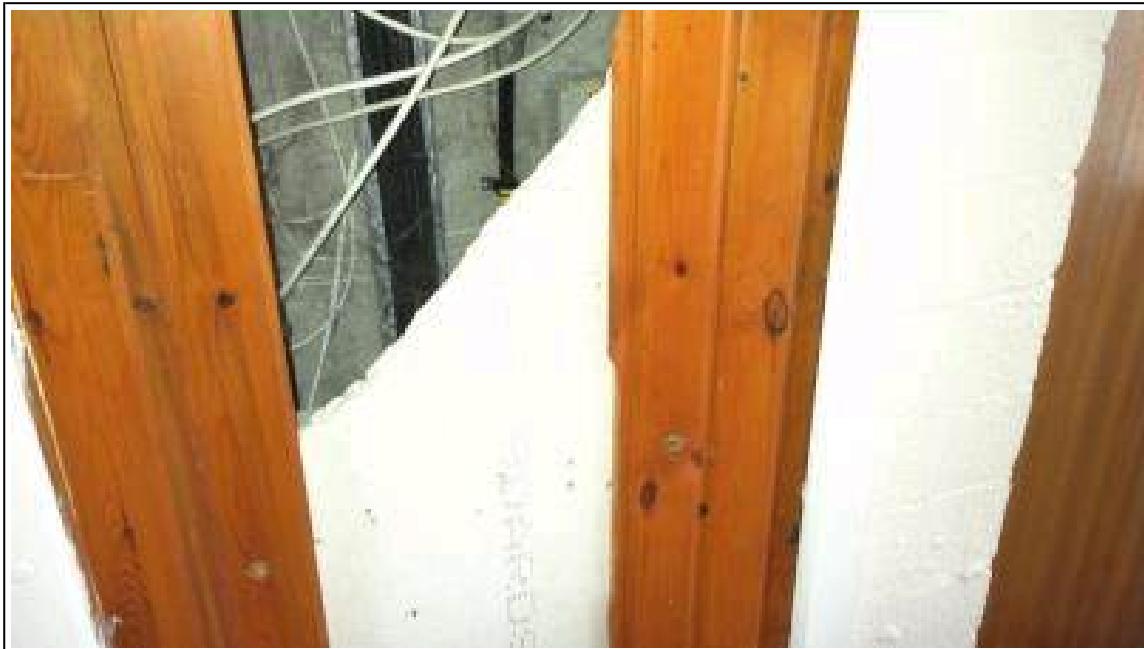
Survey Data Sheet: Conclusions & Recommendations
 Site Location: 35 - 42 Amber Court, Swindon, SN1 2HB
 Building Designation: Building 01
 Unique item Number: 6

Sample Ref	Fl	Location	Description	Qty	Analysis Result	Total M.A.S	Licensed Material Y/N
REFER (AM000003)	Ground Floor	Riser cupboard 2	Behind access panel and within void - Insulation board panel - Insulating Board	2m ²	NADIS		N

No asbestos detected in sample

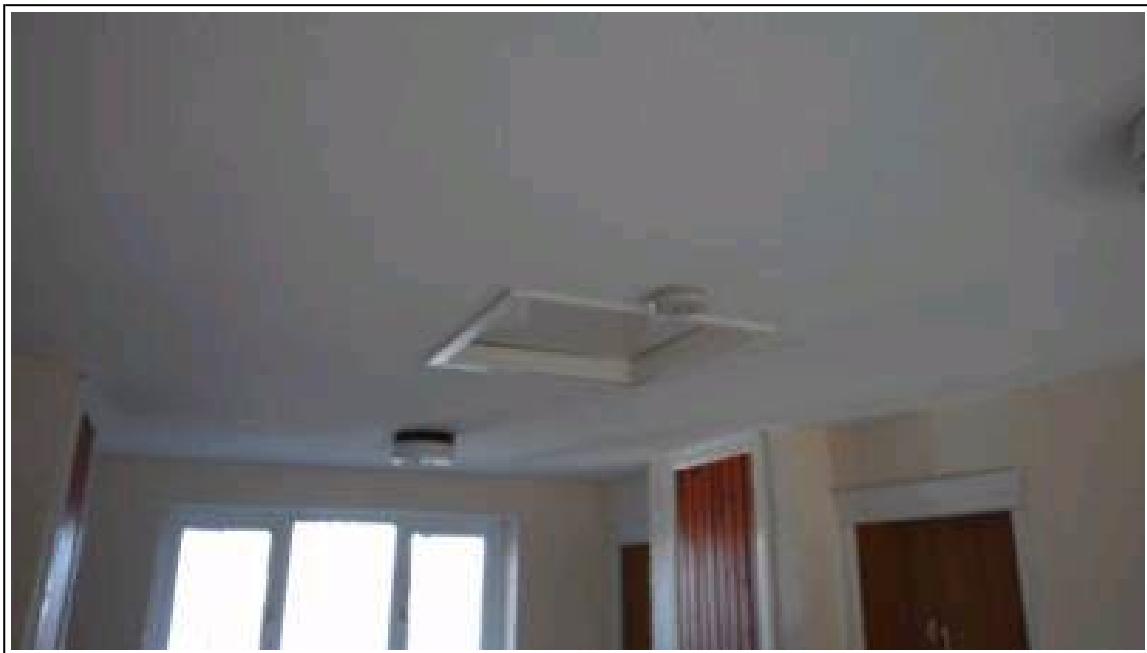
Survey Data Sheet: Conclusions & Recommendations
 Site Location: 35 - 42 Amber Court, Swindon, SN1 2HB
 Building Designation: Building 01
 Unique item Number: 7

Sample Ref	Fl	Location	Description	Qty	Analysis Result	Total M.A.S	Licensed Material Y/N
REFER (AM000001)	1st Floor	Stairs and landing	Ceiling - Textured coating - Textured Coating	21m ²	NADIS		N

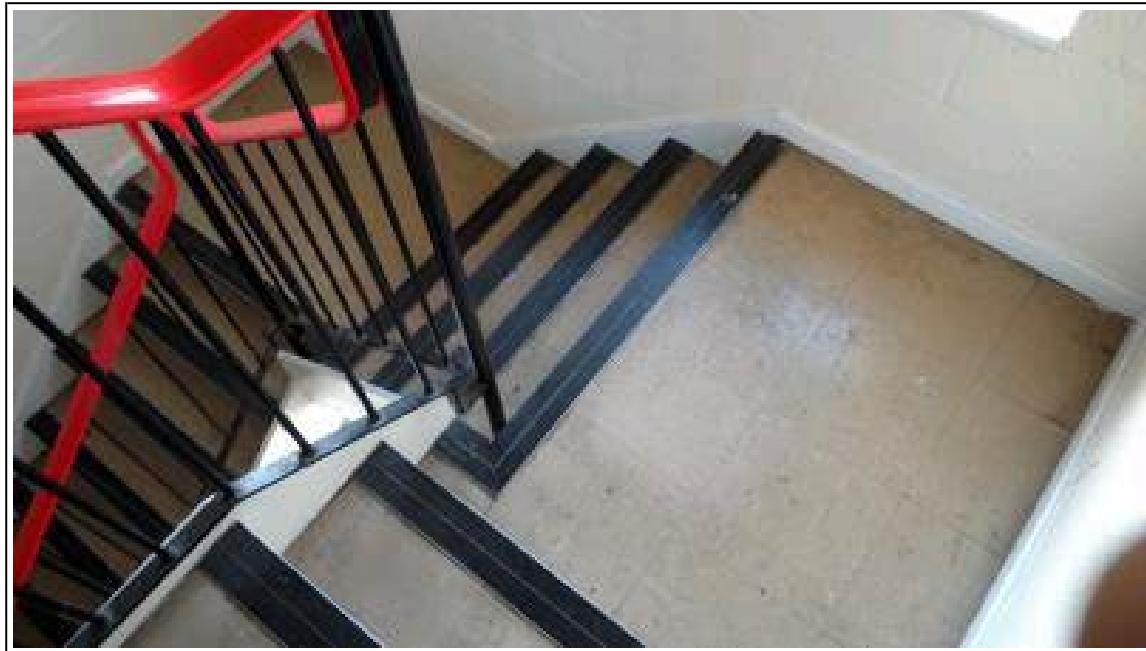
Survey Data Sheet: Conclusions & Recommendations
 Site Location: 35 - 42 Amber Court, Swindon, SN1 2HB
 Building Designation: Building 01
 Unique item Number: 9

Sample Ref	Fl	Location	Description	Qty	Analysis Result	Total M.A.S	Licensed Material Y/N
AM000004	1st Floor	Stairs and landing	Stairs - Composite stair nosing - Reinforced Composite	141m	NADIS		N

No asbestos detected in sample

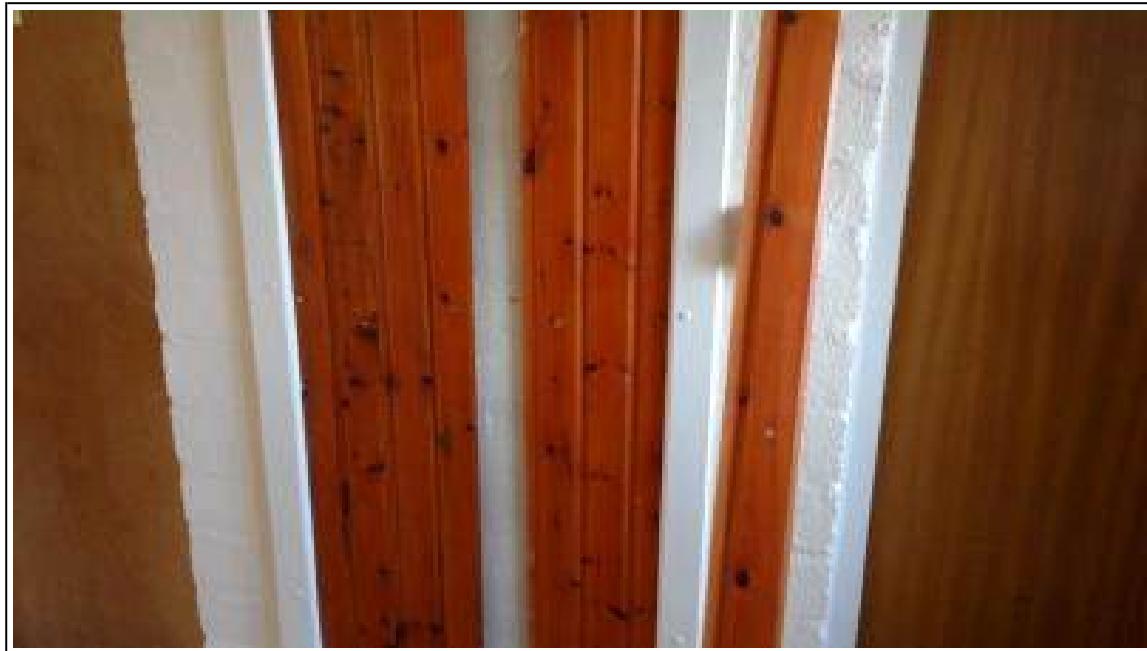
Survey Data Sheet: Conclusions & Recommendations
 Site Location: 35 - 42 Amber Court, Swindon, SN1 2HB
 Building Designation: Building 01
 Unique item Number: 10

Sample Ref	Fl	Location	Description	Qty	Analysis Result	Total M.A.S	Licensed Material Y/N
REFER (AM000003)	1st Floor	Riser cupboard 1	Behind access panel - Insulation board panel - Insulating Board	2m ²	NADIS		N

No asbestos detected in sample

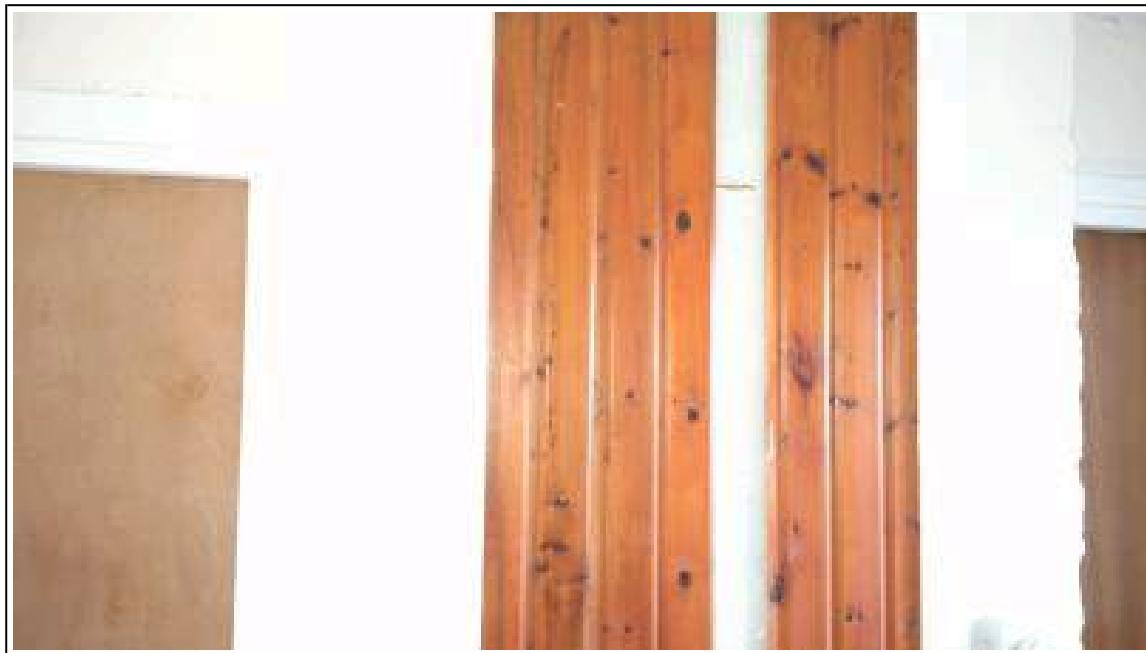
Survey Data Sheet: Conclusions & Recommendations
 Site Location: 35 - 42 Amber Court, Swindon, SN1 2HB
 Building Designation: Building 01
 Unique item Number: 11

Sample Ref	Fl	Location	Description	Qty	Analysis Result	Total M.A.S	Licensed Material Y/N
REFER (AM000003)	1st Floor	Riser cupboard 2	Behind access panel - Insulation board panel - Insulating Board	2m ²	NADIS		N

No asbestos detected in sample

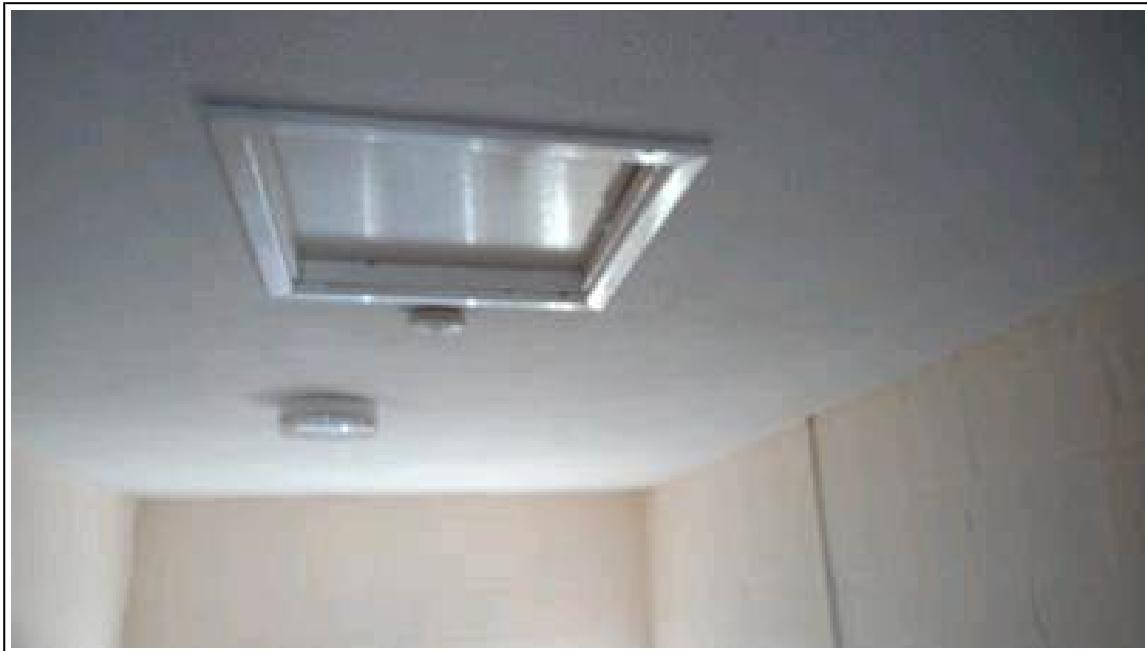
Survey Data Sheet: Conclusions & Recommendations
 Site Location: 35 - 42 Amber Court, Swindon, SN1 2HB
 Building Designation: Building 01
 Unique item Number: 12

Sample Ref	FI	Location	Description	Qty	Analysis Result	Total M.A.S	Licensed Material Y/N
Surveyed	Roof Void	Attic	No asbestos detected -		N/A		N

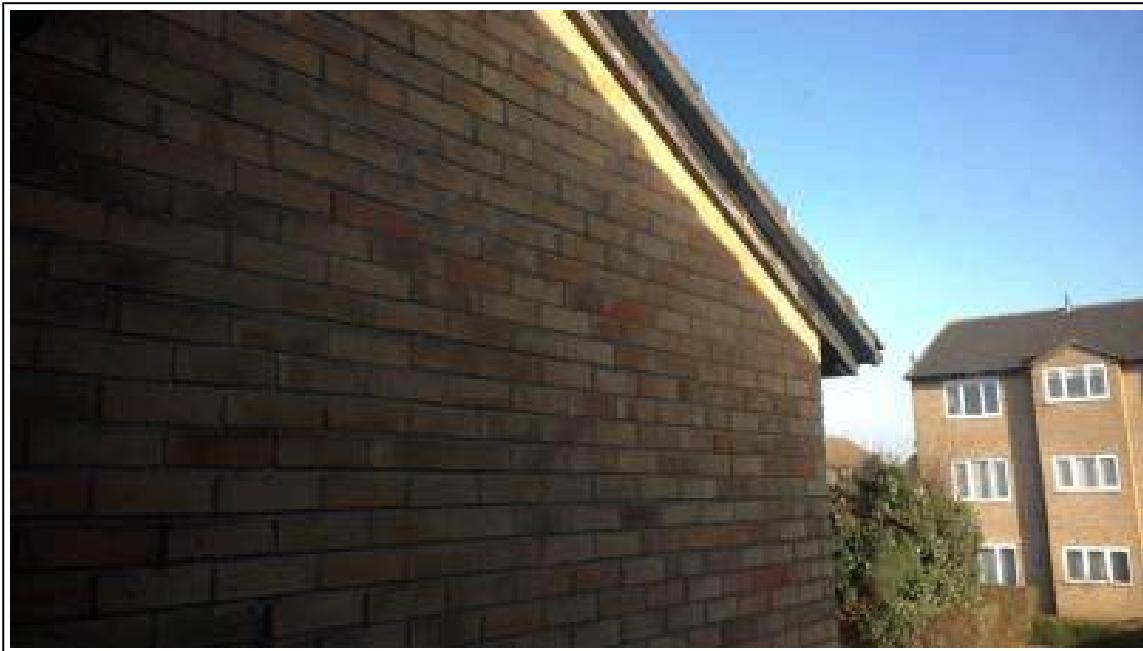
Survey Data Sheet: Conclusions & Recommendations
 Site Location: 35 - 42 Amber Court, Swindon, SN1 2HB
 Building Designation: Building 01
 Unique item Number: 13

Fl	Building Designation	Location	Asbestos Containing Material	M.A.S	Recommended Action
Ex	Building 01	External	Roof - Cement undercloak - Asbestos Cement	3	Leave & Manage

Sample Ref	Fl	Location	Description	Qty	Analysis Result	Total M.A.S	Licensed Material Y/N
AM000005	External	External	Roof - Cement undercloak - Asbestos Cement	52m	Chrysotile	3	N

Product Type	Extent of Damage	Surface Treatment	Asbestos Type	Total M.A.S	Accessibility/ Vulnerability	Combined Total for Advised Timescale
1	0	1	1	3	0	3

Recommended Action:
Leave & Manage

This material may remain in situ and be managed accordingly. Undertake continued regular recorded inspections on the condition of the material as dictated in the asbestos register and management plan. No drilling, cutting or any abrasive actions should take place on this material.
