COMBINED FIRE AND HEALTH & SAFETY RISK ASSESSMENT.

Address of premises:	35-42 Amber Court Swindon SN1 2HB
Responsible Person:	Amber Court Management (No.4) Limited
Duty Holder:	Block Management Limited
Person(s) consulted:	No occupier or other relevant person available to consult.
Assessor:	Rob Cockburn
Report validated by:	John Godfrey, G1FireE.
Date of fire risk assessment:	3 rd November 2025
Date of previous fire risk assessment:	September 2023
Suggested date for review:	November 2026

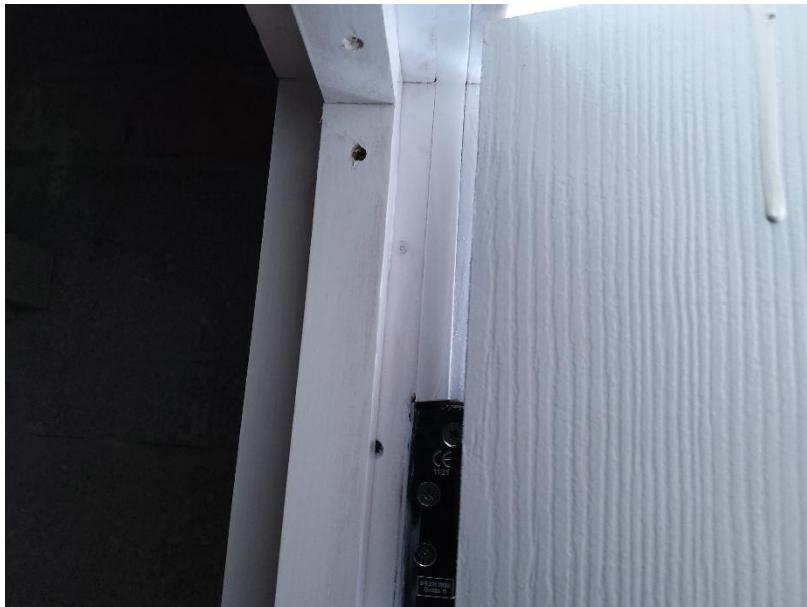
It was noted during this fire risk assessment that the identified communal area doors had the following deficiencies:

02	<p>It was noted during this fire risk assessment that the identified communal area doors had the following deficiencies:</p> <ul style="list-style-type: none"> • No smoke seals on the electrical intake cupboard door. <p>It is essential that each door communicating with the means of escape is a suitable fire door, providing a minimum of thirty minutes fire resistance, hung on three grade 13 hinges, combine cold smoke and intumescent seal, "Fire Door Keep Locked" or "Fire Door Keep Shut" signage where appropriate along with having a functioning self-closing device fitted that positively closes the door flush to the frame if a lobby door. It is recommended therefore that the RP instruct a suitably qualified and competent contractor to conduct a fire door inspection to all communal area doors providing advice on suitability as per "Fire Resisting Doors - 62.17" of Fire Safety in Purpose-Built Block of Flats. Any shortcomings identified by this inspection should be addressed as a priority by upgrading or replacing the door.</p> <p>Flat entrance doors, communal area doors, the seals and the self-closing devices should then be subjected to an annual inspection and maintenance schedule.</p>

It is essential that each door communicating with the means of escape is a suitable fire door, providing a minimum of thirty minutes fire resistance, hung on three grade 13 hinges, combine cold smoke and intumescent seal, "Fire Door Keep Locked" or "Fire Door Keep Shut" signage where appropriate along with having a functioning self-closing device fitted that positively closes the door flush to the frame if a lobby door. It is recommended therefore that the RP instruct a suitably qualified and competent contractor to conduct a fire door inspection to all communal area doors providing advice on suitability as per "Fire Resisting Doors - 62.17" of Fire Safety in Purpose-Built Block of Flats. Any shortcomings identified by this inspection should be addressed as a priority by upgrading or replacing the door.

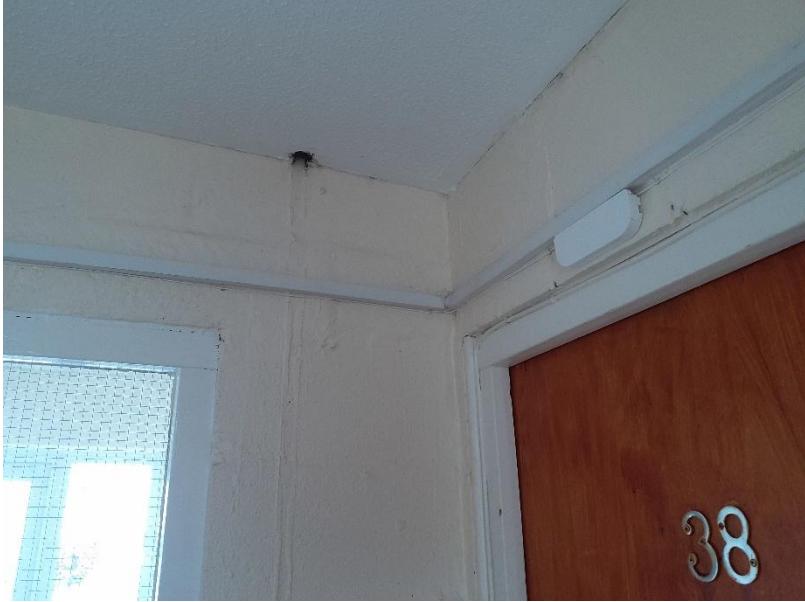
04	<p>It was noted during this assessment that there is a breach in the ceiling of the ground floor common area. It is recommended that this breach be repaired with a suitable compound capable of providing a minimum of thirty minutes fire resistance in order to adequately compartment the common areas.</p>

2	C	Action required Contractor has been instructed to repair.
05	<p>It is recommended that a suitable written record of periodic visual inspections of all access routes to the premises is implemented by the RP. This should include a record of the condition of external steps and pathways. Any defects identified should be communicated to each resident and repaired by an approved contractor as a priority.</p>	3	C	Ongoing action required DH inspect and action as required.
